NASA TN D-7968

**APOLLO EXPERIENCE REPORT -
FLIGHT ANOMALY RESOLUTION**

John D. Lobb

FLIGHT ANOMALY RESOLUTION

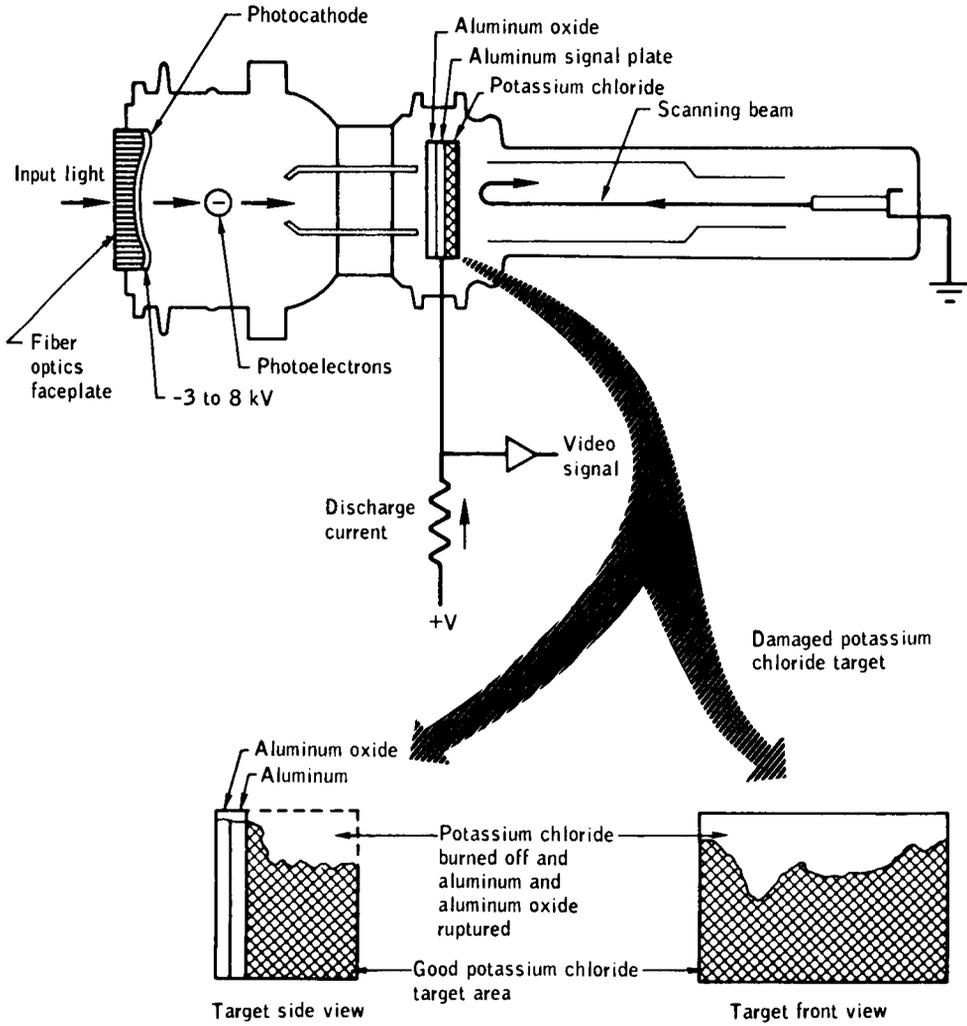
After decontamination and cleaning, the flight camera was inspected and power was applied. The image, as viewed on a monitor, was the same as that last seen from the lunar surface. The automatic light-level control circuit was disabled by cutting one wire. The camera then reproduced good scene detail in that area of the picture which had previously been black, verifying that the black area of the target was undamaged, as shown in figure 14-39. This finding also proved that the combination of normal automatic light control action and a damaged image-tube target caused the loss of picture. In the process of moving the camera on the lunar surface, a portion of the target in the secondary-electron conductivity vidicon must have received a high solar input, either directly from the sun or from some highly reflective surface. That portion of the target was destroyed, as was evidenced by the white appearance of the upper part of the picture.

Figure 14-39.- Secondary electron conductivity tube in the color television.

Training and operational procedures, including the use of a lens cap, are being changed to reduce the possibility of exposing the image sensor to extreme light levels. In addition, design changes are being considered to include automatic protection, such as the use of an image sensor which is less susceptible to damage from intense light levels.

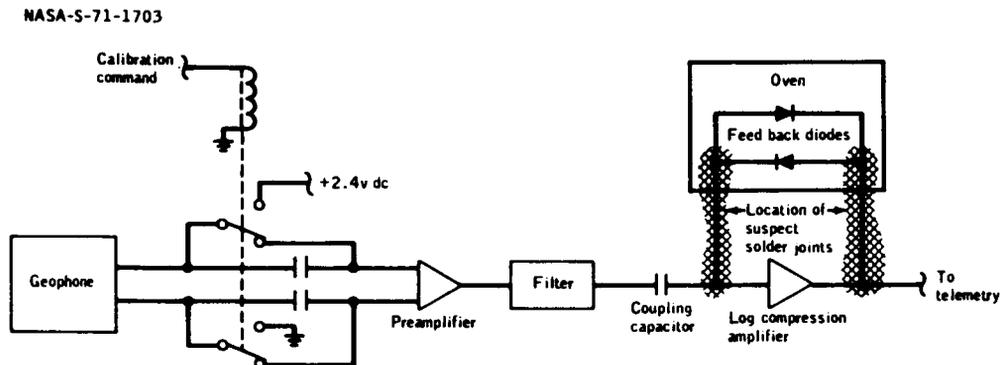
As shown in figure 14-35, each geophone channel consists of a geophone, an input preamplifier, a low-pass filter, and a logarithmic compressor amplifier. The output of the logarithmic compressor feeds the instrumentation system. The logarithmic compressor is basically an inverting amplifier with exponential negative feedback. Two diode-connected transistors between the output and input of the amplifier supply the feedback. The first diode is used for positive-going and the second for negative-going input signals. The diodes for all three geophone channels (two per channel) are physically located in an oven which controls their temperature at 105° C.

Figure 14-35.- Typical geophone channel.

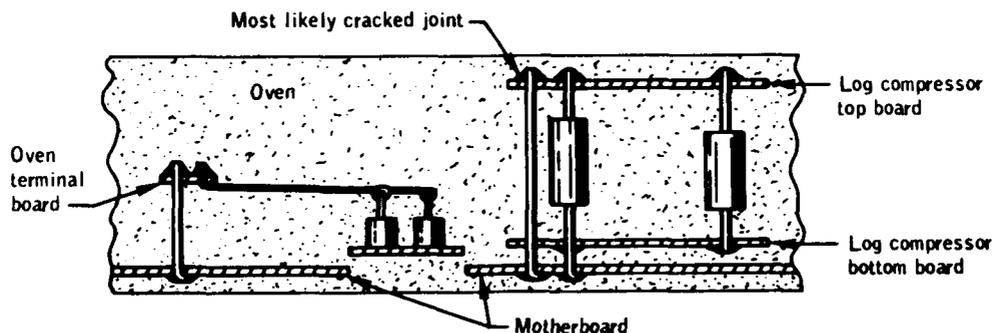
The problem was detected during the lunar night at the experiment location. Under lunar night conditions the thermal gradient between the oven (105°C) and the rest of the electronics (4.4°C) was maximum. Since thermal gradients cause mechanical stresses by differential thermal expansion, the large temperature gradient between the oven and the rest of the experiment electronics probably caused the crack.

The experiment electronics uses "cordwood" construction of the type which has caused solder cracks in other equipment. Two copper paths conduct the feedback diodes to the logarithmic compressor amplifier. A solder crack in either path would then result in the data characteristics.

There are 10 such solder joints for each geophone (fig. 14-36): four on the oven terminal board, four on the mother board, one on the top board of the log compressor module, and one on the bottom board of the log compressor module. The one most likely to fail first is on the top board of the log compressor module. Continuity at the joint recovers as long as the crack closes during the lunar day.

Figure 14-36.- Suspected cracked solder joints in amplifier.

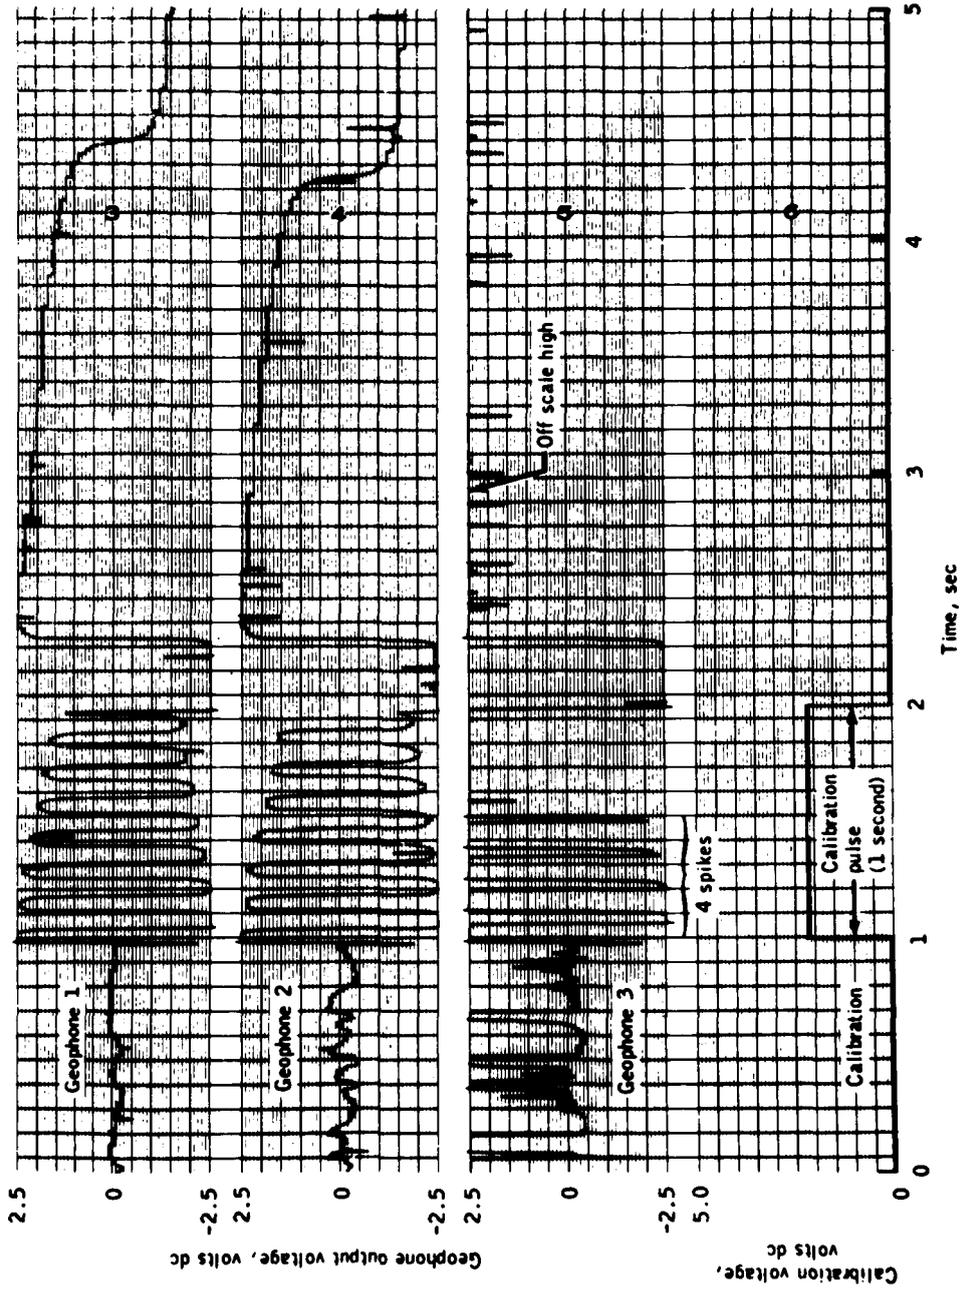
The experiment was turned on in the listening mode on March 26, 1971, and geophone 3 data were spiking off-scale high (fig. 14-34). When the geophone channels were calibrated, the geophone 3 channel went off-scale high simultaneously with the start of the calibration pulse and stayed off-scale high for the remainder of the listening period. During the 1-second period when the calibration pulse was present, data from geophones 1 and 2 showed the normal 7-hertz ringing caused by the calibration pulse. However, geophone 3 data showed four negative-going spikes coincident with the first four negative half cycles of the ringing on the other two channels. The spikes decreased in duration from the first to the last, the last having an amplitude of 90 percent of full scale (plus 2.5 volts to minus 2.0 volts). During the time that this pulse was present, the signal on channel 2 changed from minus 2.2 volts to minus 2.35 volts, indicating that channel 3 was operating at an apparent gain of 30 times the channel 2 gain.

Figure 14-34.- Geophone calibration data.

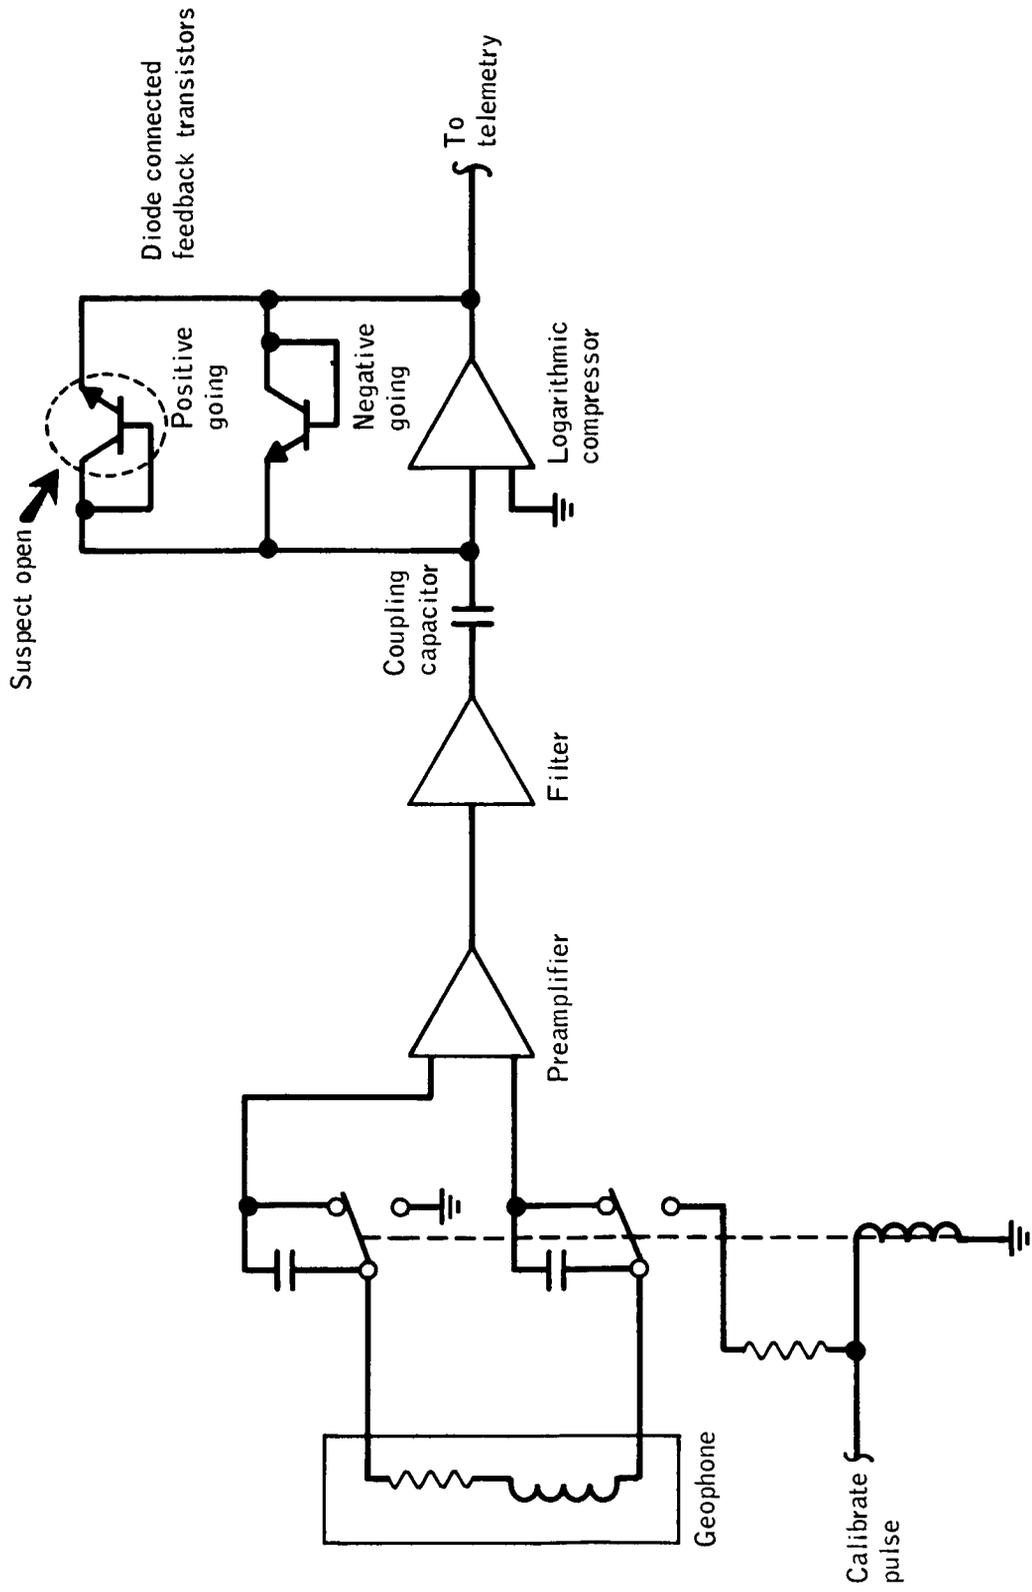
A failure in the geophone, preamplifier, or filter could produce a bias offset; however, the compressor input coupling capacitor would block the bias offset and the output signal would not remain off-scale high. Had the input capacitor shorted, the output would be shifted, but not off-scale-high. The fault, therefore, must have been within the logarithmic compressor circuit (fig. 2).

Figure 2.- Geophone and signal conditioner.

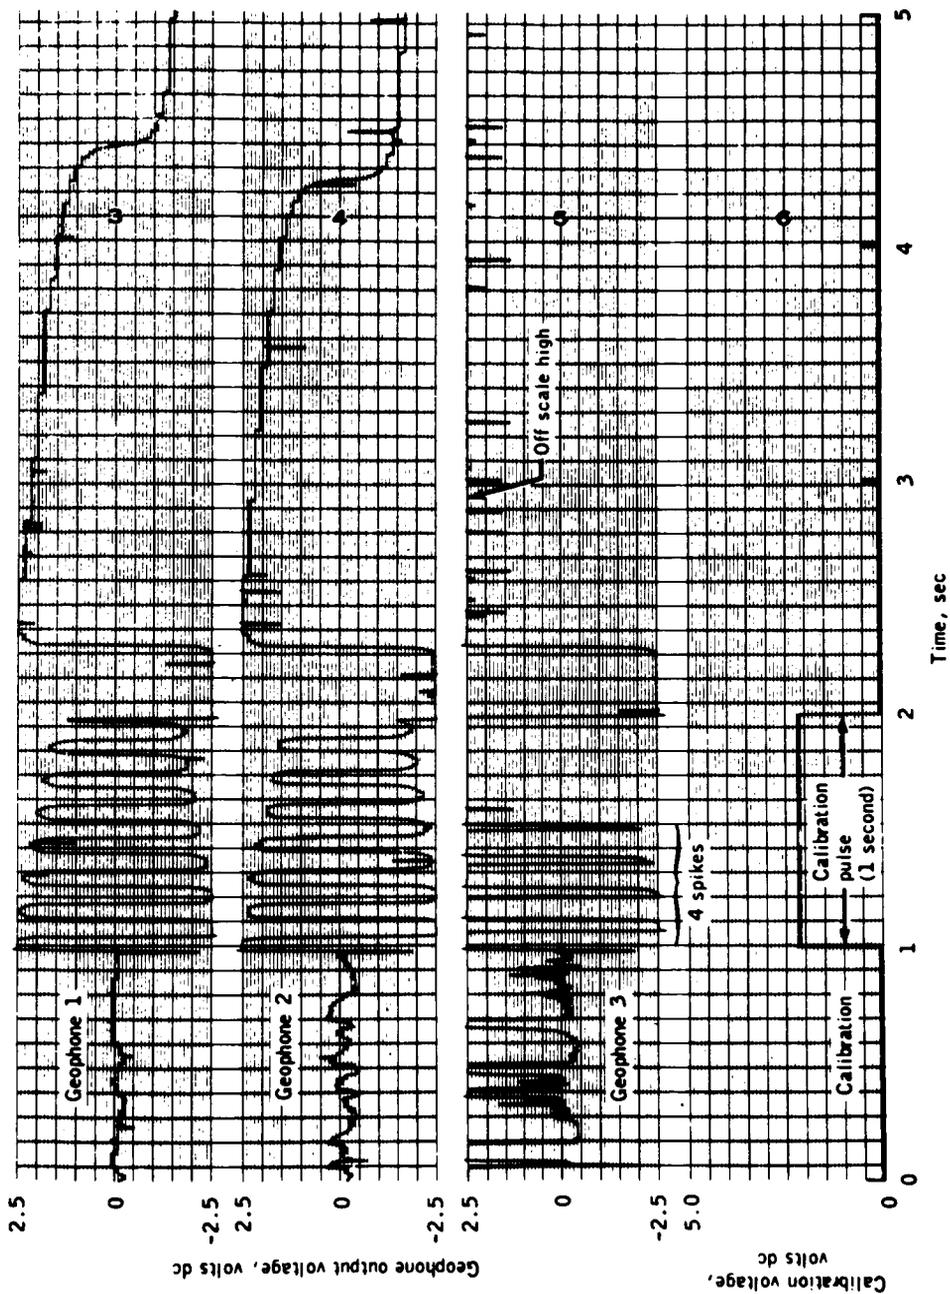
All three geophone channels were calibrated, and the geophone 3 channel went off-scale high simultaneously with the application of the calibration pulse (fig. 3). The channel stayed off-scale high for the remainder of the listening period. During the 1-second period when the calibration pulse was present, the geophone 3 data showed four negative-going pulses from off-scale high. Pulse widths were shorter than corresponding oscillations on geophones 1 and 2, and decreased in width from the first to the fourth pulse. The characteristics of these pulses indicate that the geophone 3 channel was operating at a higher gain than geophones 1 and 2 during the calibration period, and that its output was biased off-scale high.

Figure 3.- Geophone calibration data on March 26, 1971.

The failure was duplicated by opening the positive-going diode-wired transistor. This saturated the amplifier input transistor, and drove the output off-scale high. When signals large enough to drive the input stage out of saturation were present, the output responded and the amplifier gain was not compressed until the output voltage was driven to zero. The part of the signal which went below zero voltage was then compressed by the negative-going feedback diode and the narrow pulses shown in figure 3 were produced.

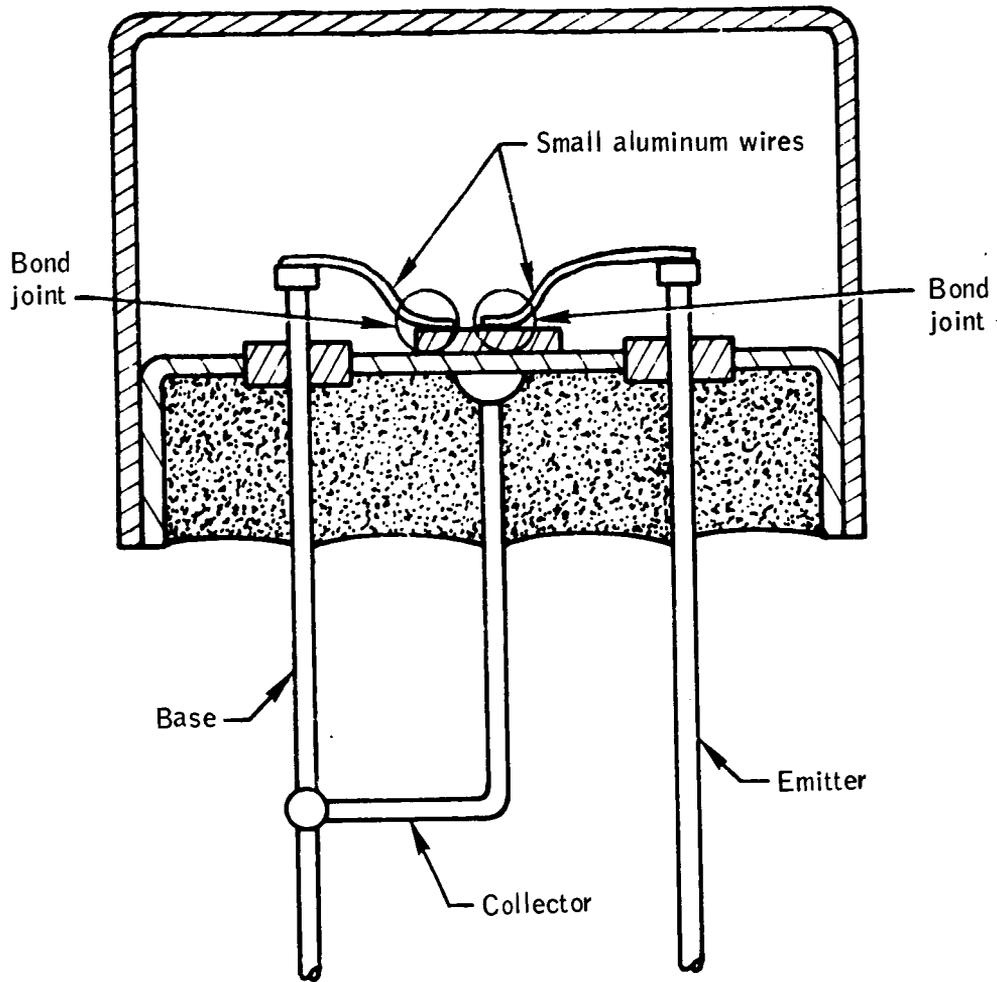
Figure 4.- Diode-wired 2N2484-2B transistor.

No corrective action was taken since the history of the transistor indicated that a generic problem did not exist.

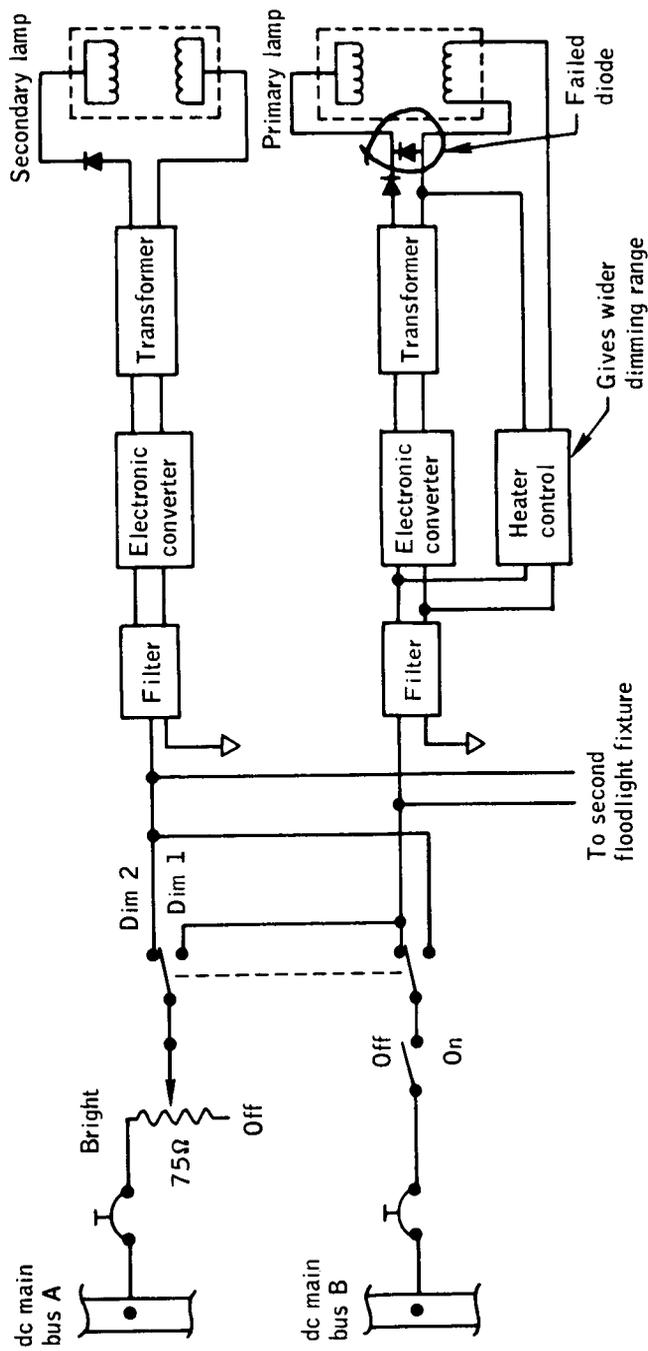
The primary lamps probably failed because of excessive operation time in the dimmed position prior to flight.

Figure 1.- Floodlight circuit.

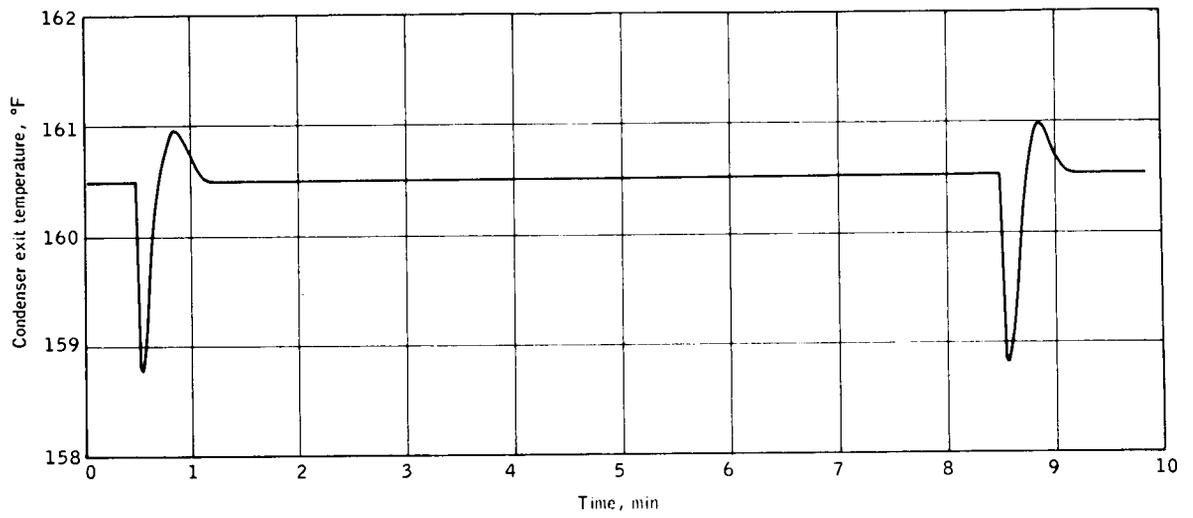
Figure 1.- Apollo 10 condenser exit temperature disturbance.

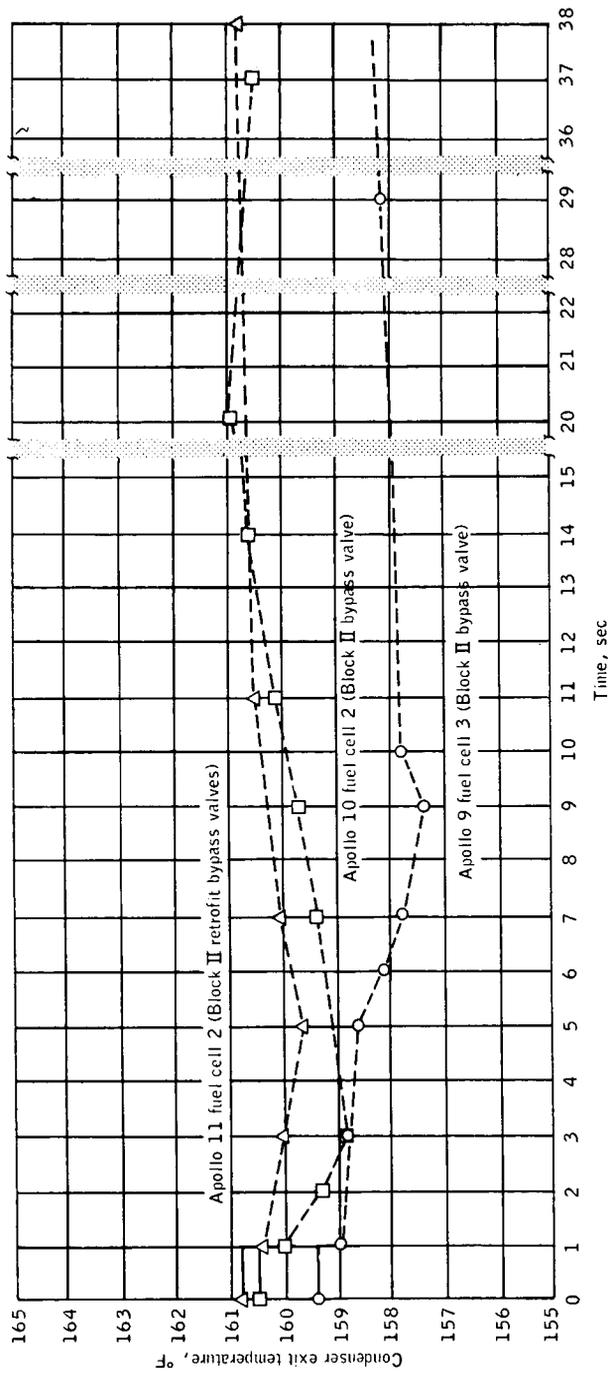
Figure 2.- Typical condenser exit temperature disturbance.

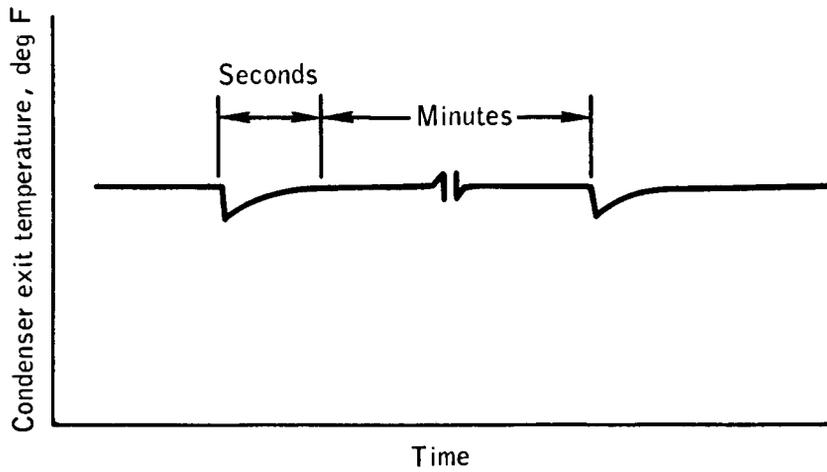
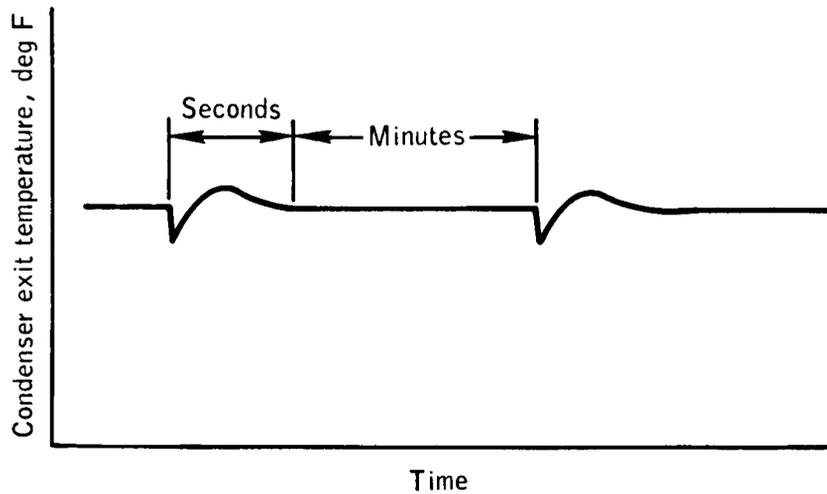
In the case of a service propulsion firing, a momentary gravity field is created in a direction coincident with the downward flow of condensate through the condenser. This, in effect, cleans the tube walls by flushing the condenser entirely of condensate. The resulting very large subcooled condensate globule affects not only the temperature sensor but also the Vernatherm element and causes the valve to react accordingly. The resulting variation in condenser exit temperature is shown in figure A-4 (lower view).

Figure A-4.- Variations in condenser exit temperature resulting from condensate slug flow.
